Manhole Inspection Summary

Manhole # S43C2_031MH

Location Address: **3801 Saint Margaret St**

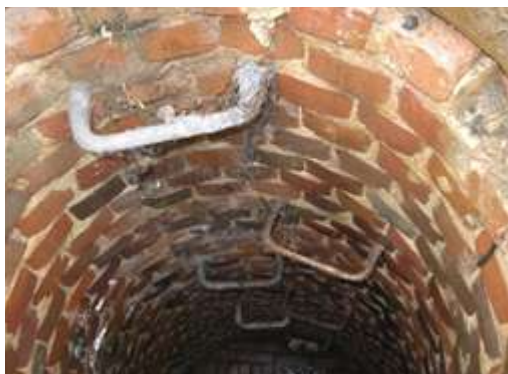
Steps

Count: **6** Missing: **0** ☐ Corroded

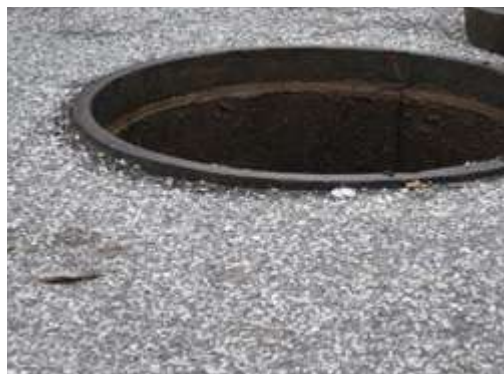
Defect 2

Offset: **1** (in.)

Above grade

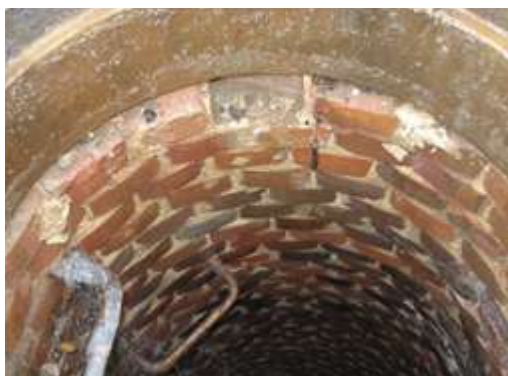
Defect 1

Infiltration: ☐ None ☐ Joint ☐ Cracks ☒ Mortar ☐ Roots ☐ Wall

Condition: ☐ Sound ☐ Cracked ☐ Root Intrusion ☒ Loose Brick ☐ Deteriorated

Frame offset/mortar

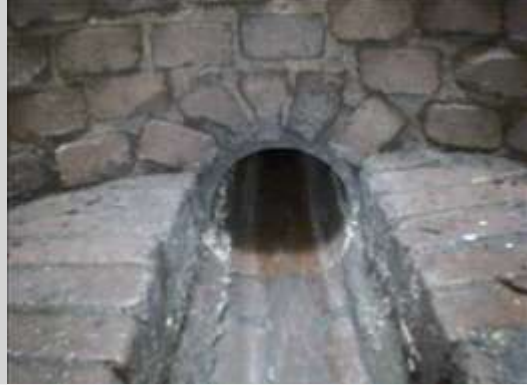
12 O'Clock Outflow

8 in. Circular Gravity Sewer
Pipe Out @ 12 O'Clock

Pipe Height: **9.6** (in.) Rod and Bar (Angled)
Pipe Material: **Clay** ☐ Pipe Lined
Invert Depth: **11.59** (ft.) Flow Characteristics: **Fast**
Deposits: ☒ None ☐ Mud ☐ Sludge ☐ Debris ☐ Grease
Silt Depth: (in.) Deposits Extent:
Infiltration: **None** Pipe Seal Cond: **Sound**

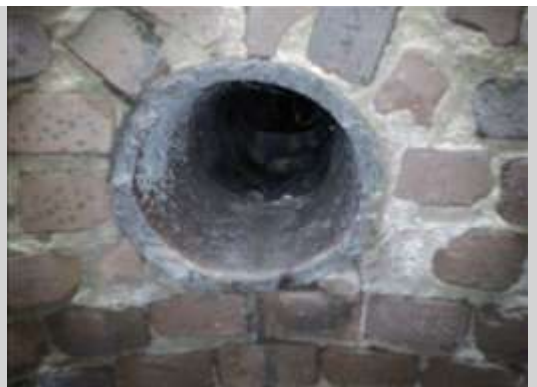
6 O'Clock Inflow

8 in. Circular Gravity Sewer
Pipe In @ 6 O'Clock

Drop In @ 6 O'Clock

Pipe Height: **9.6** (in.) Rod and Bar (Angled)
Pipe Material: **Clay** ☐ Pipe Lined
Invert Depth: **9.71** (ft.) Flow Characteristics: **Fast**
Deposits: ☒ None ☐ Mud ☐ Sludge ☐ Debris ☐ Grease
Silt Depth: (in.) Deposits Extent:
Infiltration: **None** Pipe Seal Cond: **Sound**

Drop: **Outside** Rod and Bar
Angled: **Yes** Reading: **10.37** (ft.)
Inv Depth: **11.37** (ft.)

Drop Condition: **Open**
